# INDOOR AIR QUALITY ASSESSMENT

**Furnace Brook Middle School  
500 Furnace Street  
Marshfield, Massachusetts**

Prepared by:  
Massachusetts Department of Public Health  
Bureau of Environmental Health  
Indoor Air Quality Program  
June 2019

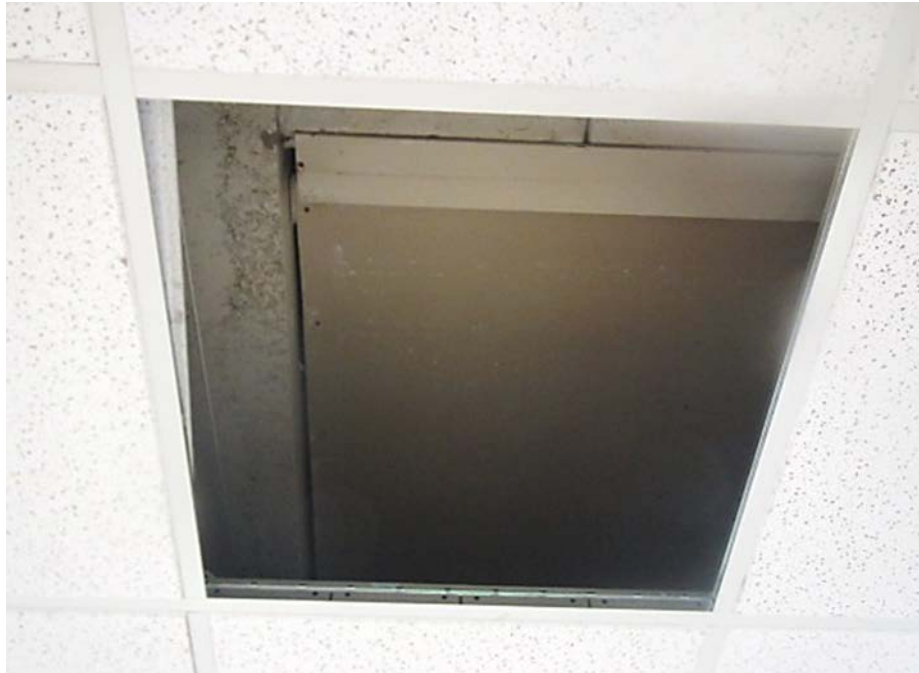
**Picture 1**

Exposure to low levels of total volatile organic compounds (TVOCs) may produce eye, nose, throat, and/or respiratory irritation in some sensitive individuals. To determine if VOCs were present, BEH/IAQ staff took measurements with a photo-ionization detector (PID) and examined rooms for products containing VOCs. As mentioned, the assessment was prompted by odor complaints, described by occupants as a "chemical, glue-type odor" School/maintenance staff believed that the odor may be related to roof work. BEH/IAQ staff removed ceiling tiles and observed an abandoned skylight above the ceiling tile system (Picture 1). Measurable levels of TVOCs (up to 77 ppm) were detected above the ceiling when the PID probe was held near spaces around the skylight where drafts could be detected. The source of odors is likely roofing compounds/materials (TREMCO, 2017).

**Sealed skylight above ceiling in Classroom 16, note spaces around edges where drafts/odors were detected**

Once detected, the occupants of the classroom were temporarily relocated and the skylight was recommended to be sealed as airtight as possible using caulking and/or plastic/duct tape, until it could be permanently sealed properly.

1. Ensure skylight is sealed as airtight as possible using caulking/duct tape/plastic.
2. Keep univent off and windows shut until odors are eliminated to prevent pressurization of Classroom 16, which can force odors into adjacent areas.
3. Seal any utility holes, particularly along pipes/exterior wall (Picture 4) into Room 16 A.
4. Over the summer examine more permanent solutions to seal the skylight and eliminate source of odors.
5. Refer to resource manual and other related IAQ documents located on the MDPH's website for further building-wide evaluations and advice on maintaining public buildings. These documents are available at <http://mass.gov/dph/iaq>.

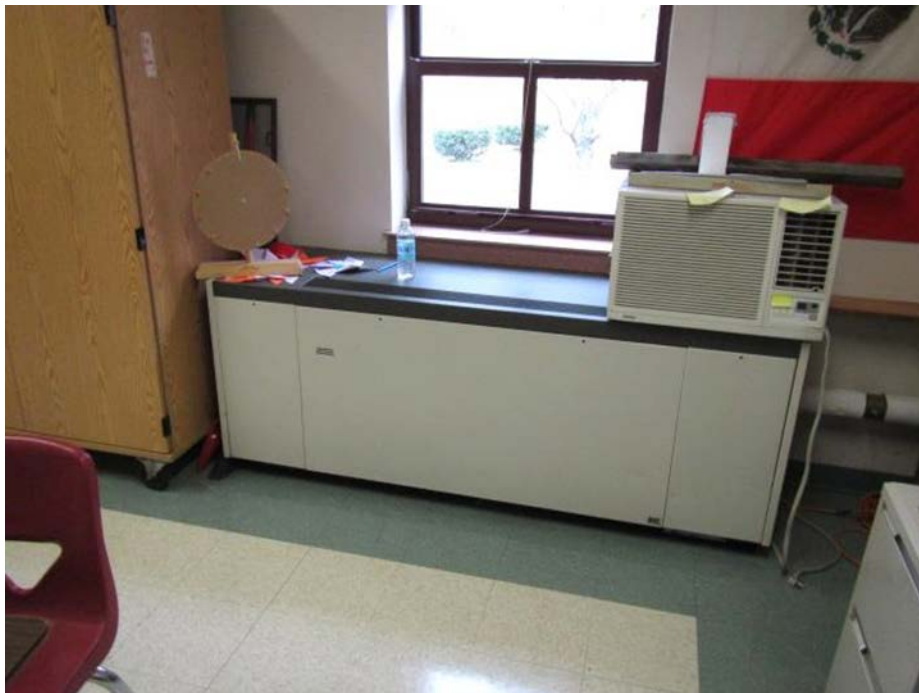
**Picture 2**

Mechanical ventilation for classrooms 16, and most general classrooms, is provided by unit ventilators (univents) located near classroom windows (Picture 2). Univents draw air from the outdoors through a fresh air intake located on the exterior wall of the building (Picture 3) and return air through an air intake located at the base of the unit. Fresh and return air are mixed, filtered, heated or cooled and provided to rooms through an air diffuser located in the top of the unit (Figure 1). As stated previously, the univent in classroom 16 was deactivated (in the off cycle), therefore no mechanical source of fresh air was being introduced at the time of assessment. It was reported that univents are controlled by an integrated computer system and their operation is tied to a carbon dioxide sensor. Once the carbon dioxide sensor reaches its set

**Typical classroom univent**

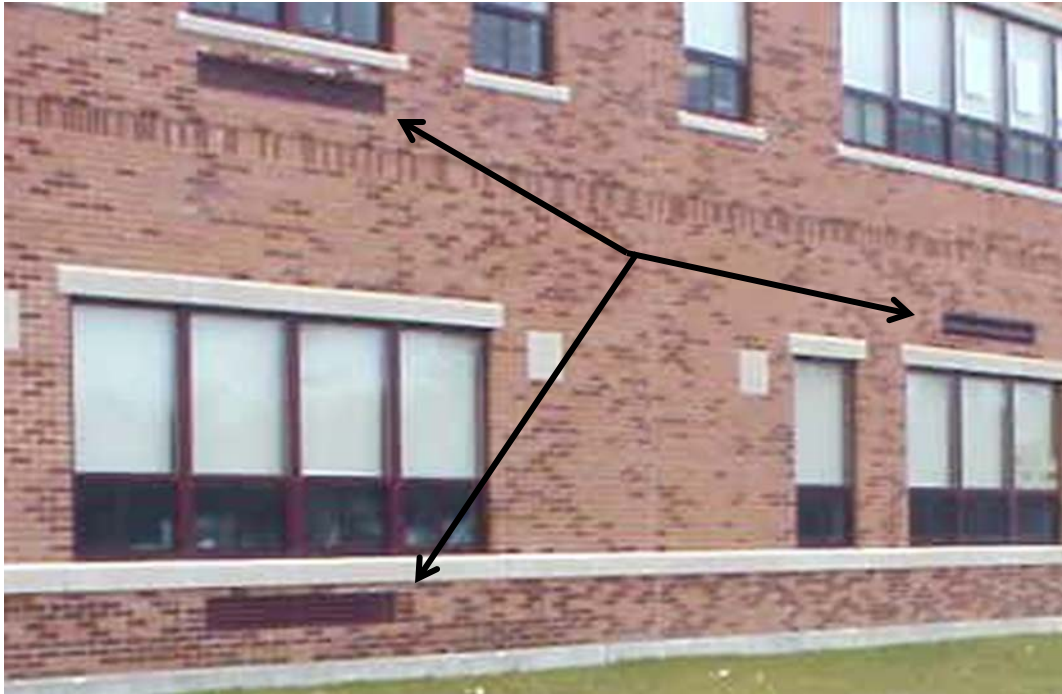
**Picture 3**

**Univent fresh air intakes (arrows)**

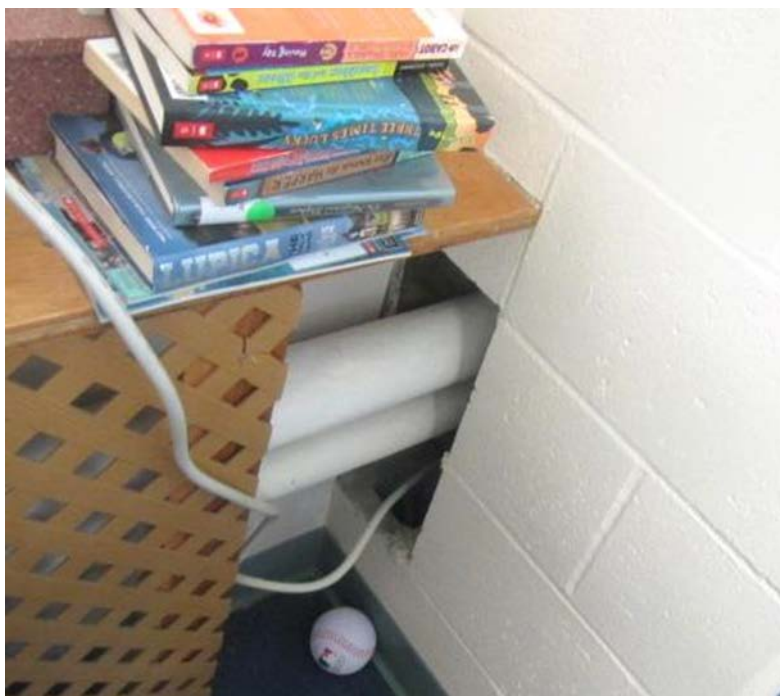
**Picture 4**

**Open pipe chase through interior wall of Classroom 16 into 16A**
